# Historic Buildings Preservation Plan

Town of Hadley  
Massachusetts

Olde Mohawk Masonry  
& Historic Restoration,  
Inc.

APRIL 29, 2013

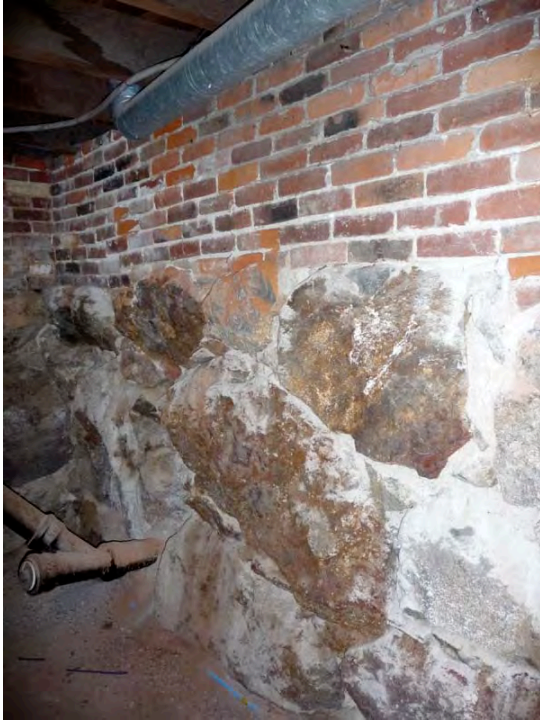
Figure 1- North Elevation at basement showing brick spalling.

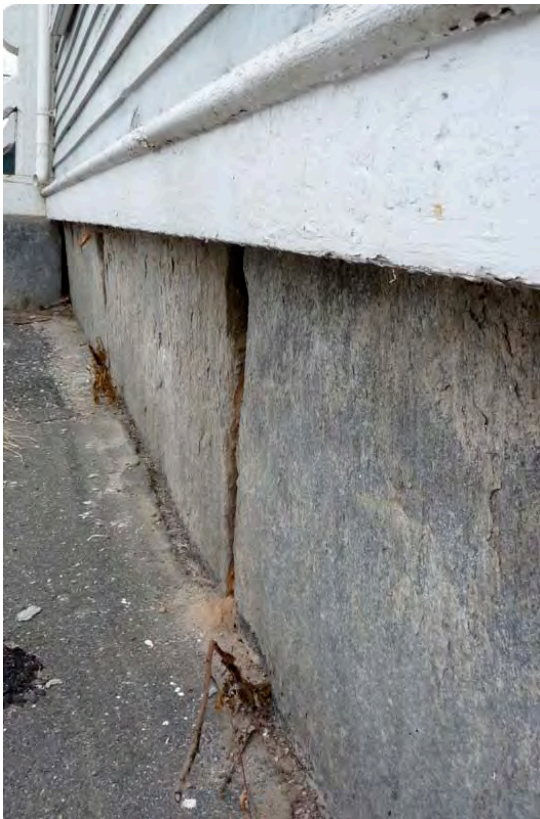
Figure 2- West Elevation showing minor shift of capstone, washed-out mortar and brick dust.

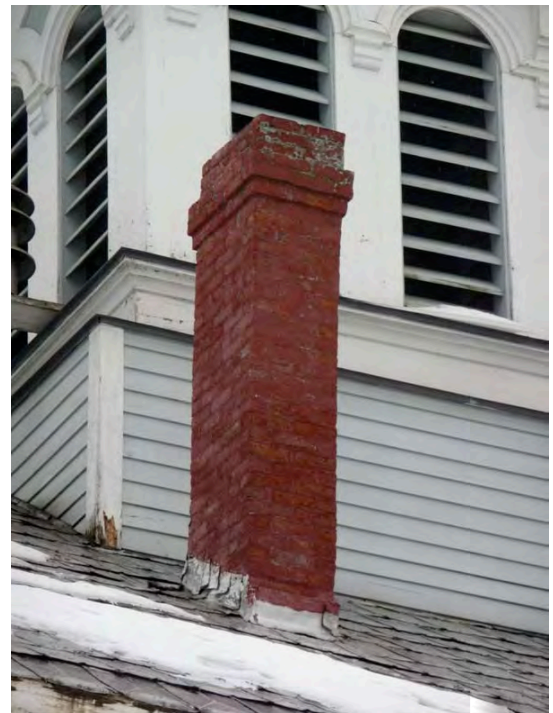
Figure 5- North Elevation showing roof flashing at chimney.

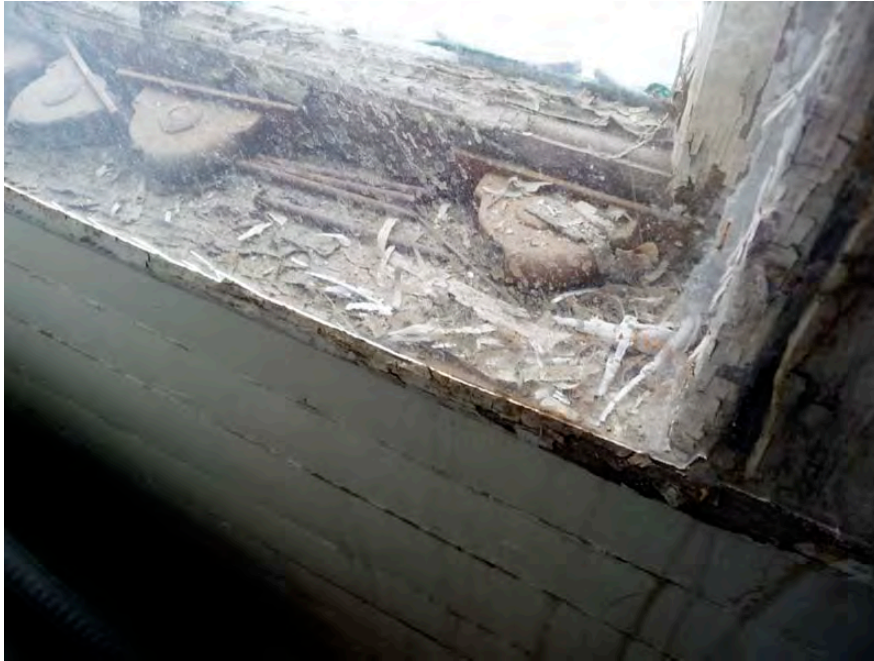
Figure 6- Interior window damage from condensation due to interior storm window.

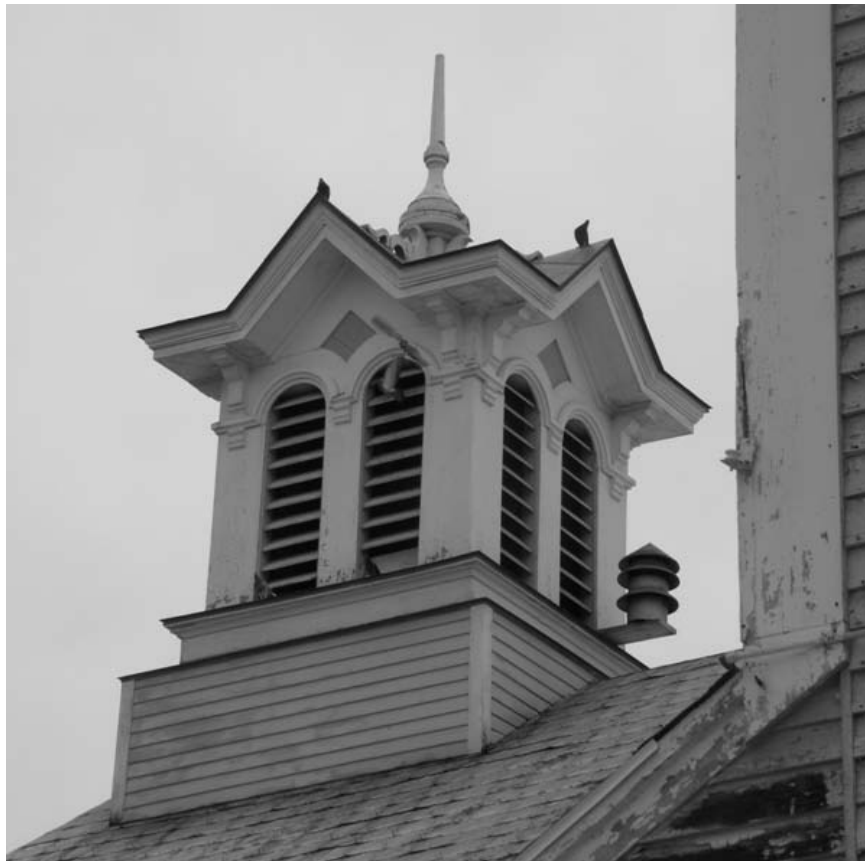
Figure 7- South Elevation of Cupola showing water damage from roof run-off.

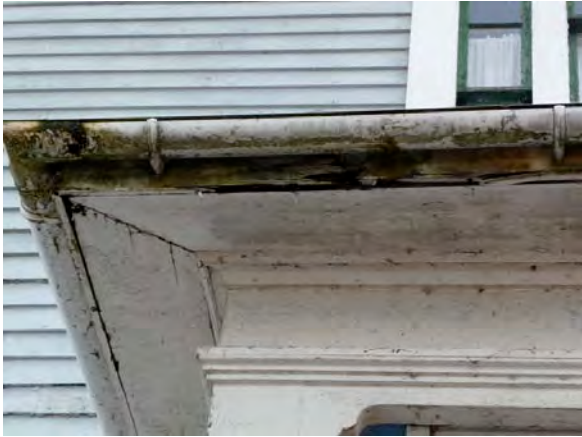
Figure 8- West Porch roof deterioration at eave and cornice.

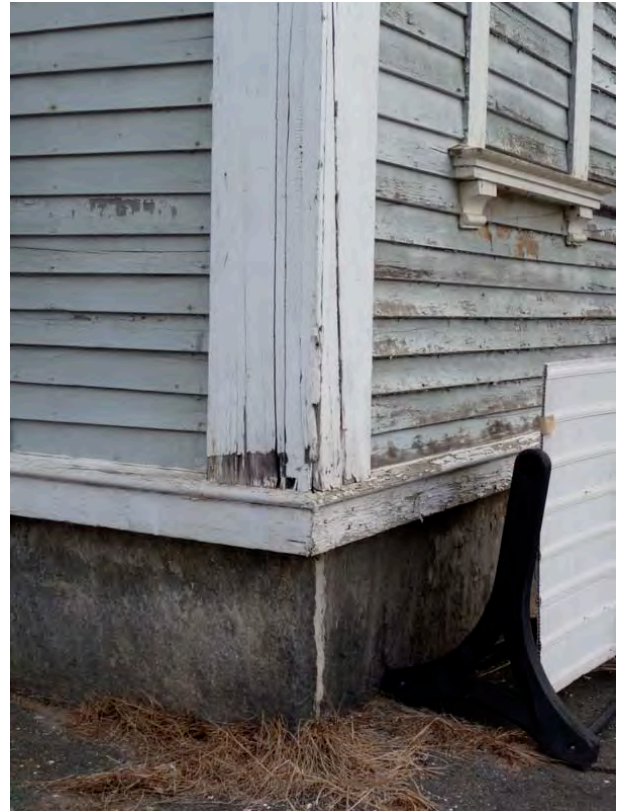
Figure 10- Southwest corner post deterioration from roof run-off and splash-back.

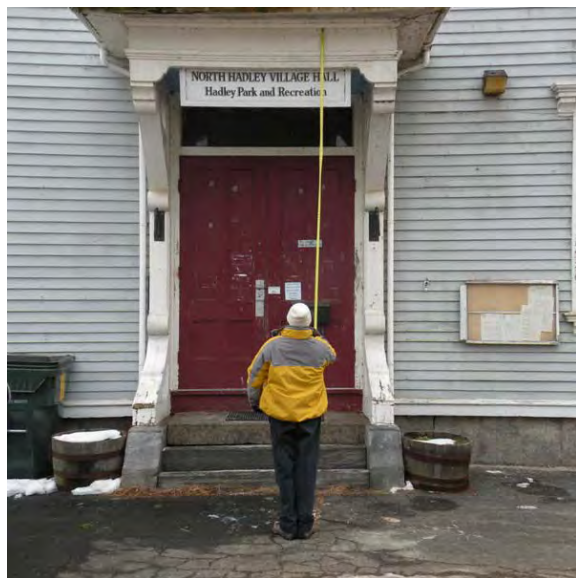
Figure 9- West Porch steps with differential settlement.

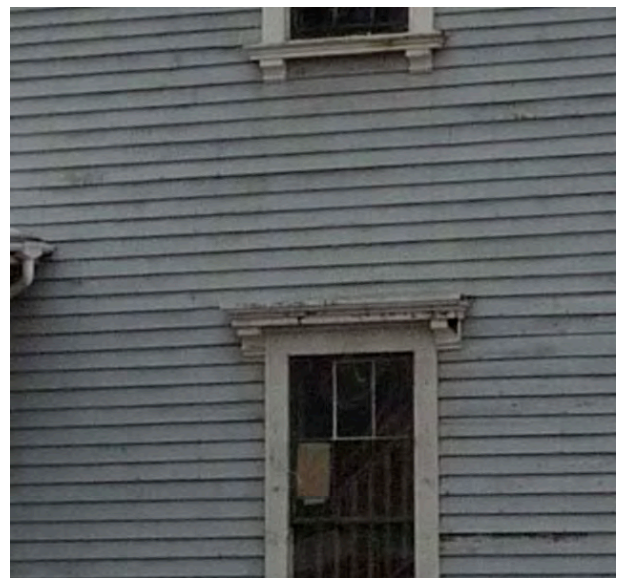
Figure 11- West Elevation window bracket requiring Dutchman repair.

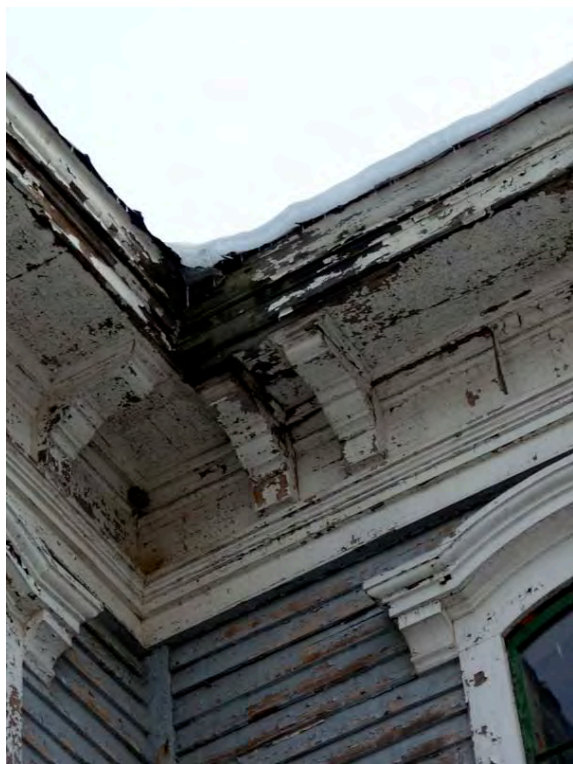
Figure 12- Cornice and soffit deterioration from roof run-off at the Southwest corner elbow.

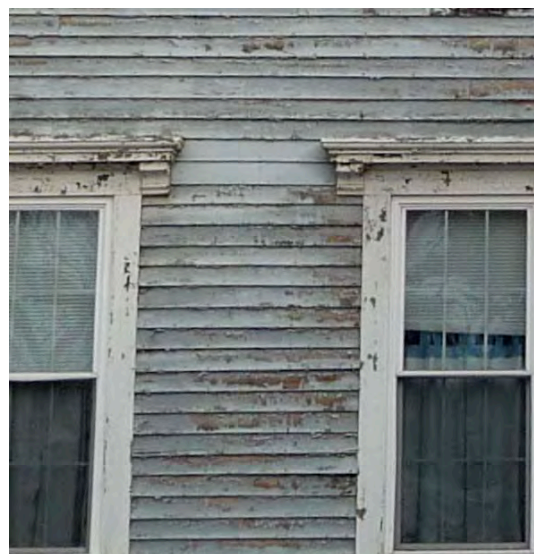
Figure 13- South Elevation showing bow in exterior clapboards.

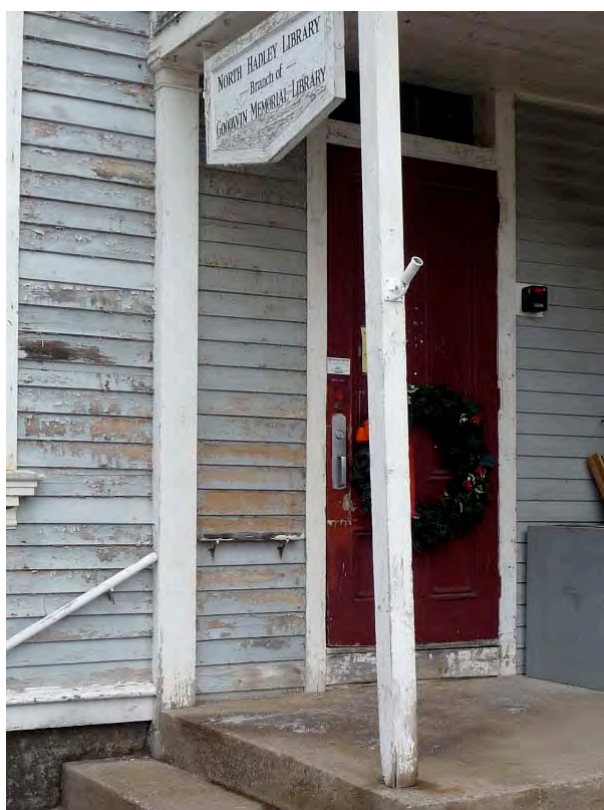
Figure 14- South Porch Elevation showing dislodged and deteriorated post.

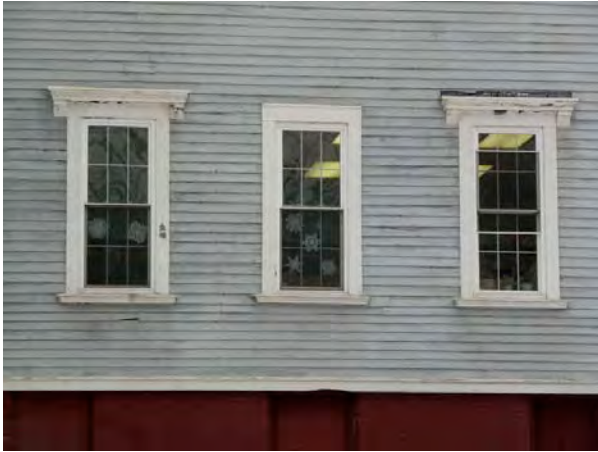
Figure 17- East Elevation showing missing window hood.

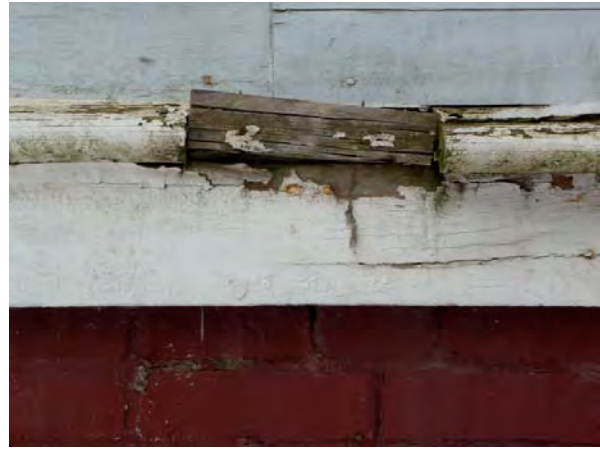
Figure 19- North Elevation showing deterioration at water table from roof run-off.

- Replace clapboard where needed.
- Reconstruct water table [Figure 19].

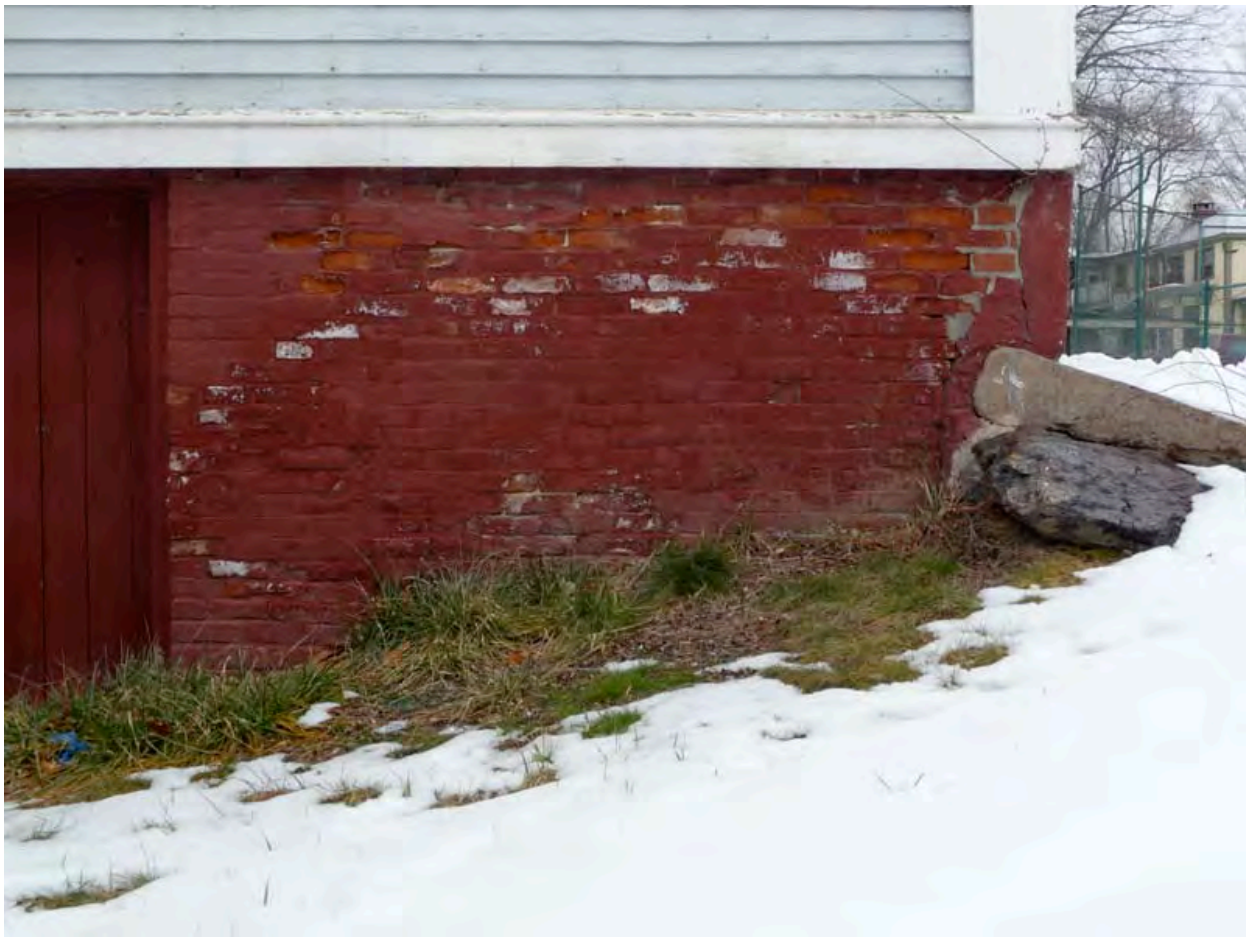
Figure 18- East Elevation at Northeast corner showing spalled brick, efflorescence and inappropriate repair at capstone.

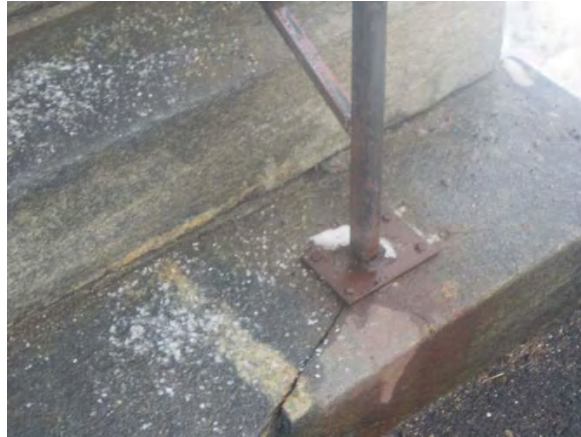
Figure 1. Several stair treads have been destroyed by rusted railing mounts that were not maintained and caused the stone to crack. Each stairway has heaved, treads have cracked and failed because moisture was allowed in and, over decades, the brick masonry support structure beneath deteriorated and failed.

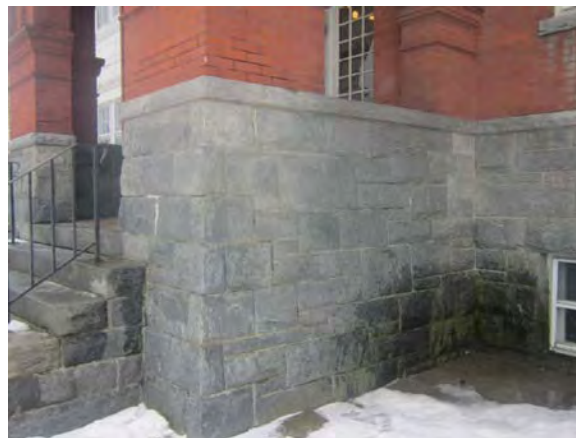
Figure 2. Algae and other biological growth is evidence of roof and site drainage issues, particularly on the northern side of the building. The introduction of gutters will alleviate this issue. The growth can be safely cleaned with any number of commercially-available, anti-microbial solutions.

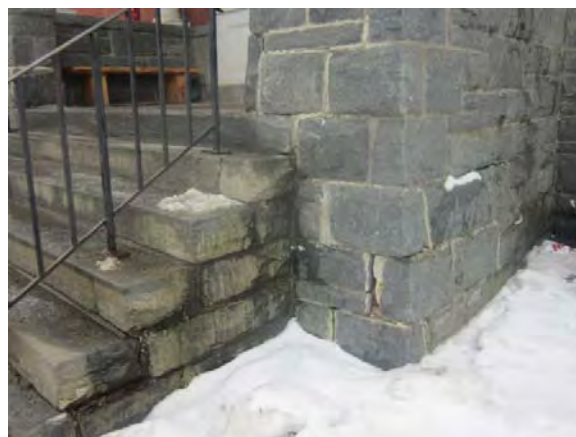
Figure 3. The stairs and abutting walls of the eastern porch. Failure to maintain mortar joints, particularly with cap stones, has allowed moisture to infiltrate. The infill freezes, expands, and forces facing stones to bulge outward.

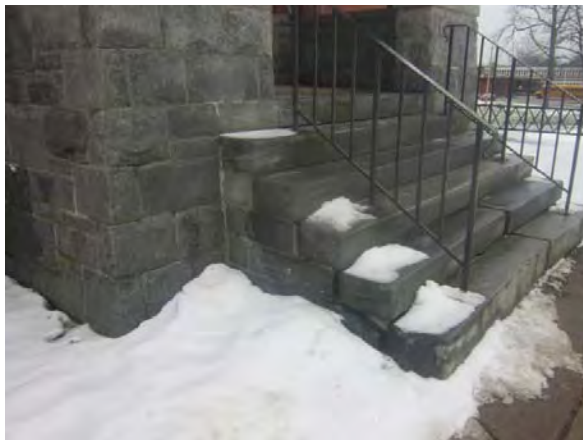
Figure 5. The stairs of the northern porch have failed. Beneath the steps are stringers, typically made of brick. When the joints between the treads are not kept pointed or closed with appropriate adhesive mastic, water gets inside. The bricks supports are destroyed and, over the years, the less-supported treads sag. The stone steps crack and become askew.

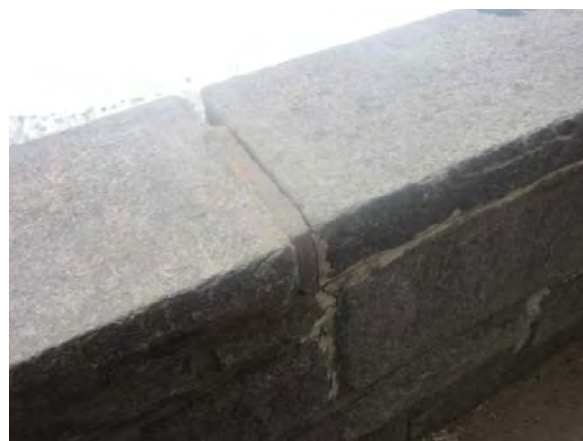
Figure 6. A failure to keep cap stones pointed or closed off with appropriate adhesive mastic will allow water inside. That water, during freeze-thaw cycles, will destroy mortar joints and, ultimately, the structural integrity of the wall will be compromised.

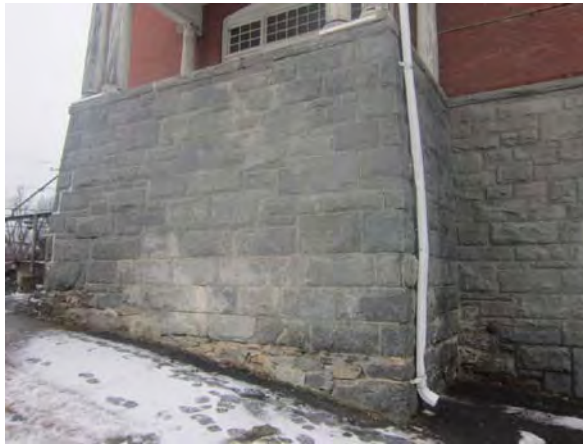
Figure 7. Water infiltration, detailed in the preceding photo, has compromised the mortar joints on this side of the porch. Without proper attention, in short time this side will start to bulge out and rebuilding will be necessary. Note the exposed portions of the once sub-grade rubble foundation wall. Erosion and/or settlement has presumably lowered grade since the date of original construction.

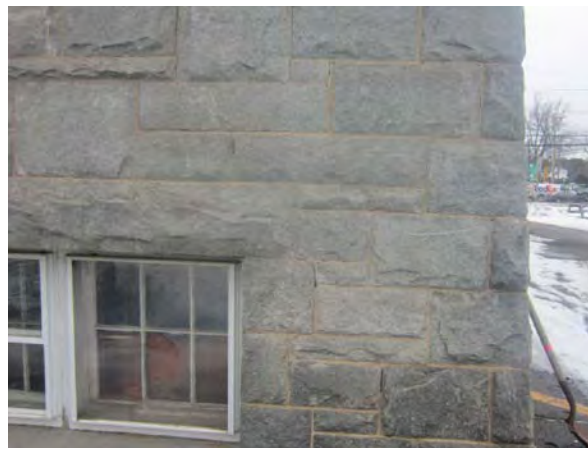
Figure 8. Extensive cracking is visible through the mortar joints at the southeast corner of the building (typ.) The installation and monitoring of tell-tales will help determine if movement is occurring or not. Cellar window. (\$15b) is missing storm inserts. Two panes of glass are broken and “boarded closed.” The missing storms are allowing precipitation to rot the sill and window.

There are cracks in at the four corners of the building and a handful of other specific locations that may be directly attributed to building settlement [figure 8]. Tell-tale gauges should be installed and monitored through four seasonal changes to detect any movement. Each week the gauges are manually inspected and findings recorded. For the sake of continuity and consistency, every effort should be made to minimize the number of individuals performing the inspections. Given the lack of roof and site drainage it is possible that heaving is occurring and causing movement in the foundation. Detection of movement is an indicator that a structural engineer should be consulted. Once it has been established that there is no movement, the cracks in the stone [figures 22, 23, 24] should be filled with an epoxy or low-shrinkage grout to prevent further water infiltration.

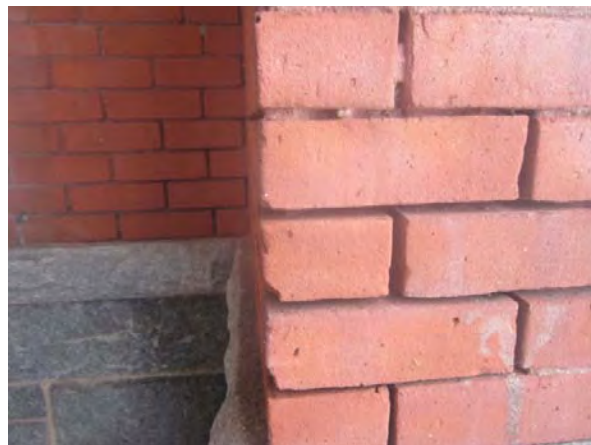
Figure 9. Detail of the deterioration of the mortar joints on the north porch. Some minor pitting of the face of the brick is detected, but not enough to warrant replacement of the masonry units. Again, the repointing of masonry facades is a maintenance-level action that will promote the longevity of the wall system.

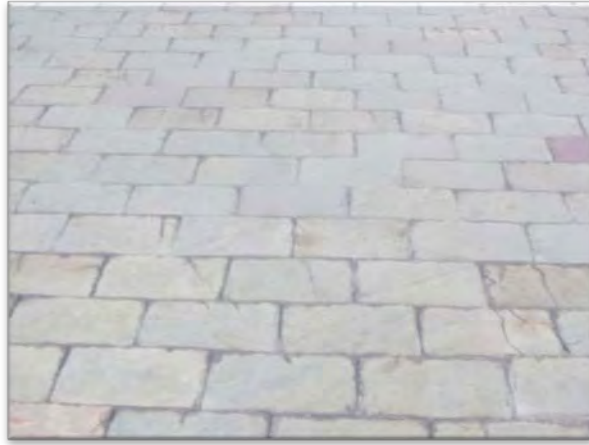
Figure 10. The semi-weathering, Vermont gray-green "Sea Green" slate is in good condition. It is not possible to determine how long the slate will last. This slate has been quarried for less than 170 years and many of the earliest buildings slated with it still retain their original roofs. Maintenance is the key to the longevity of this roof system.

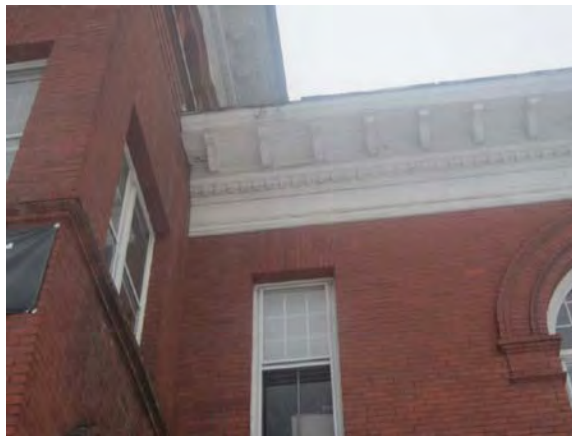
Figure 11. Broken slate at the eaves allowed water runoff to damage the cornice. The damage to the slate may have initially been caused by icy snow sliding off the tower roof, above.

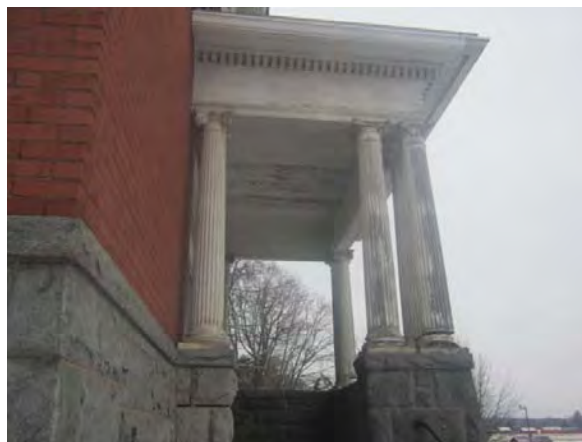
Figure 12. While the western porch requires the most carpentry-related work, its masonry is in better overall condition than the other two. The volutes of the capitals are missing or in poor condition some are askew from their plinths. One column is completely missing.

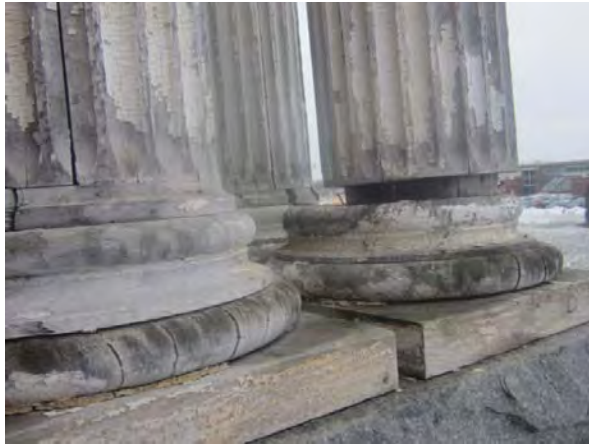
Figure 13. Detail of the column bases. Decades of neglect have allowed the columns to deteriorate to this condition. The fact that they have survived, even in this condition, is a testament to the quality of materials. Note the “alligatoring” (crazed and cracking) of paint in the flutes, an indicator of lead-based paint.

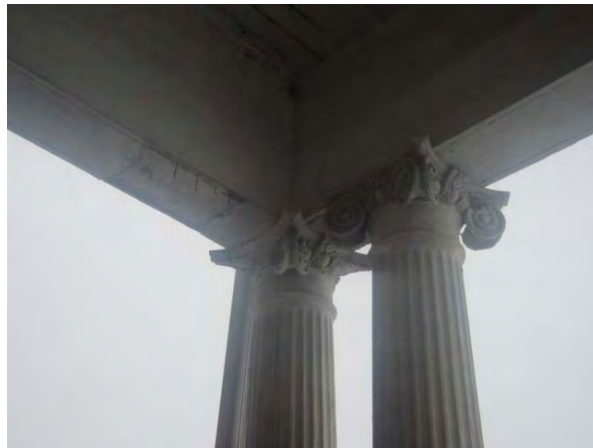
Figure 14. Missing column. While the capital of the corner column is missing two volutes, its neighbor, to the left, is missing altogether. These columns support the super structure of the porch roof above them.

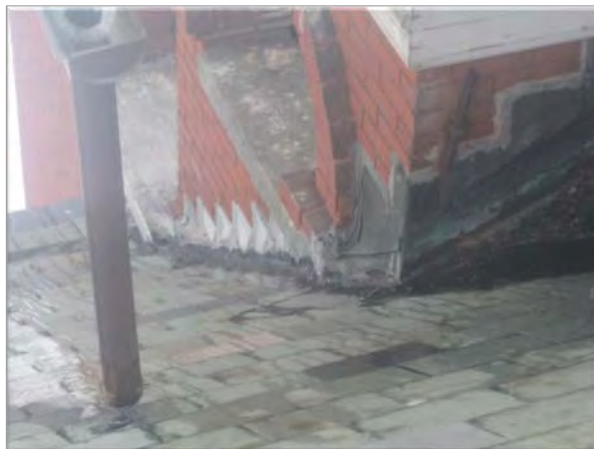
Figure 15. This picture details the stop gap measures that have been employed at the masonry sidewall and cricket. The roofing tar contains bituminous by products that actually accelerates the deterioration of the copper sheet metal. The repairs are inappropriate, unsightly, and destroying adjoining slate.

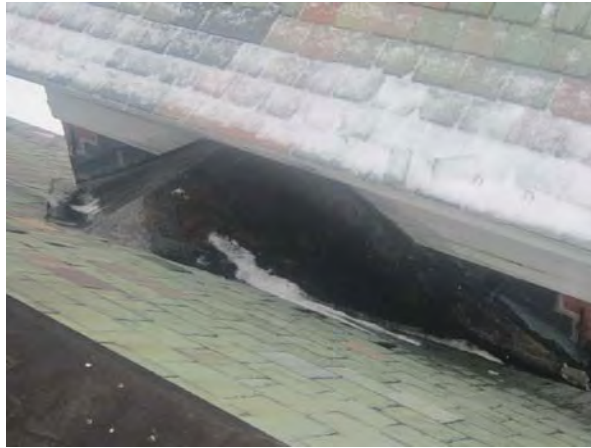
Figure 16. The cricket behind the tower. Like the sidewall detail discussed in photo two, above, inappropriate materials and methods have been employed in an effort to prevent water infiltration. Slate roofs will last for hundreds of years. Replacement of sheet metal flashing assemblies, like this, after one hundred years of service life are considered part of the maintenance of a slate roof system.

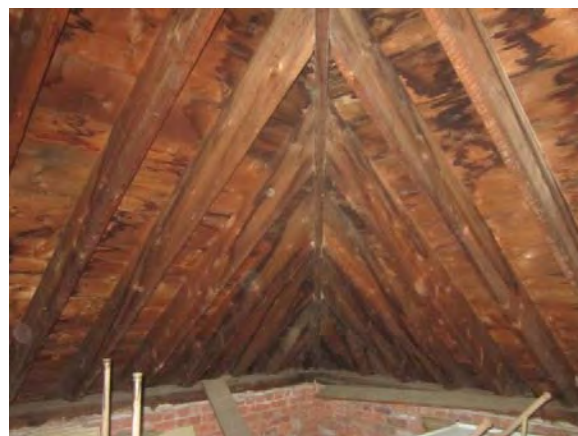
Figure18. Roof structure. The structural members of the roof frame are in very good condition. No deflection or rotting was detected. Water staining, as shown in this image, was most likely incident specific or related to a missing slate which has since been replaced.

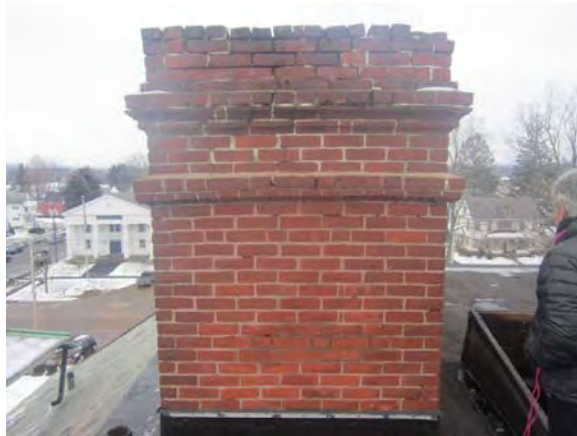
Figure 19. The chimney stack has not been maintained. A section of the sheet metal cap is missing and has allowed the top three courses of brick to fall into disrepair. These courses must be re-laid and sections of the stack repointed with an appropriate mortar.

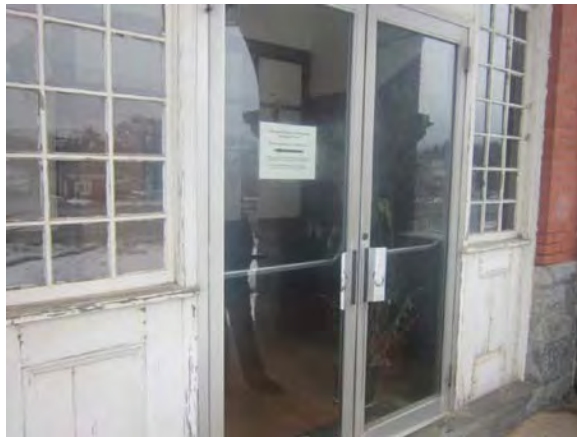
Figure 20. The aluminum entry doors on the west porch are functional. Windows, panels and trim are in need of restoration.

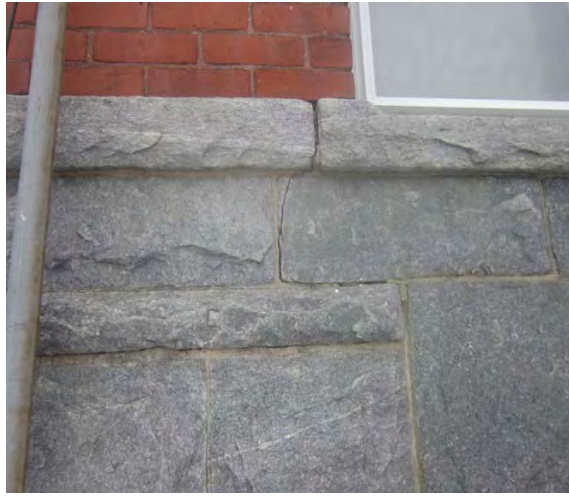
Figure 22. A failure to maintain the mortar joints of the belt course allowed precipitation to infiltrate on the northern elevation and exacerbating movement. Note crack in the stone of the foundation.

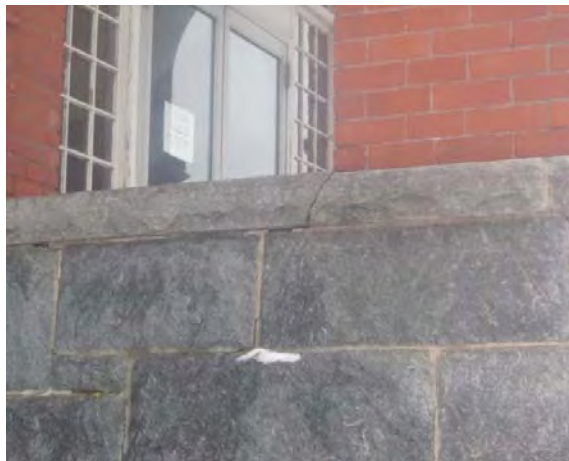
Figure 23. The cause of the crack in this cap stone, on the northern porch, is not immediately evident. There are no signs of failure elsewhere in the tower, and one corner is supported above this section of the porch. The use of tell-tales will indicate if any movement is taking place. It is most likely that some minor settlement occurred during or soon after construction. The result caused the crack in the cap to appear thereafter.

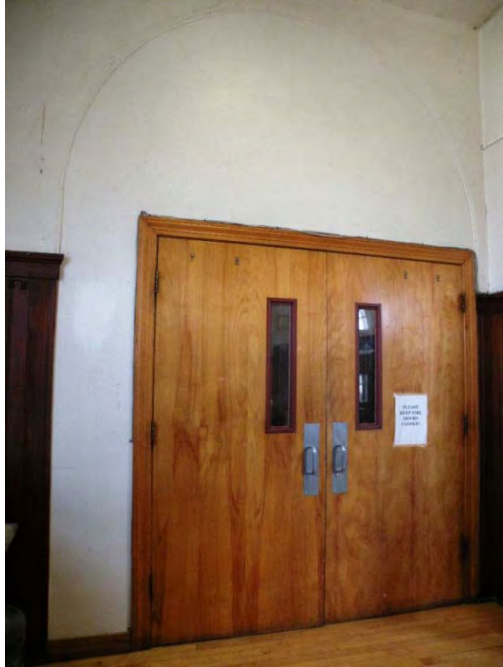
Figure 25- 2nd Floor Corridor showing sheetrock wall in-filled in plaster arch.
