BUILDING USE AUDIT - CONDITION ASSESSMENT

Town of Hadley, Massachusetts

Town Hall

100 Middle Street

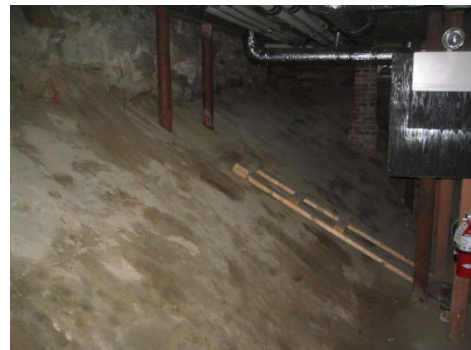
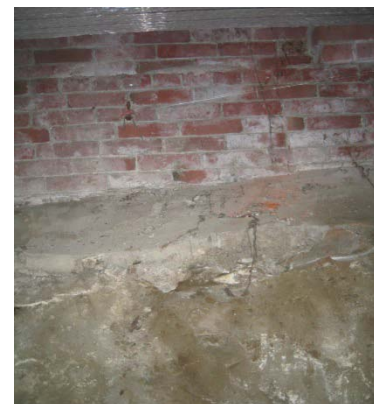
- The hand excavation of the Basement in 1902 (originally a crawl space) was carefully sculpted at the building perimeter to avoid the need to underpin the original foundation walls. The excavation was sloped downwards from the bottom of the foundation wall to the present Basement grade on a relatively steep slope (Top Photo). A thin concrete course (roughly 1" to 4" thick) was added over the sloped soil, presumably to minimize the potential for sloughing. The concrete course has broken up and has failed in a number of locations (Bottom Photo). Reportedly, there are significant vibrations from vehicular traffic on Route 9 (directly north of the building); such vibrations could disturb the relatively sandy soil. Although this condition has apparently existed for over 100 years, FBRA recommends that a Geotechnical Engineer be consulted to review this issue and to make recommendations for additional stabilization of the excavation as may be appropriate.

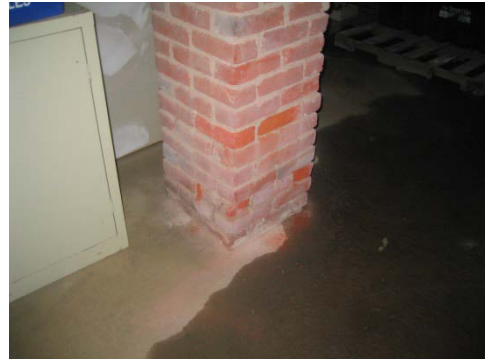
- Water was observed in certain areas of the Basement floor (Photo). The perimeter brick foundation walls also show signs of moisture absorption (efflorescence present). Moisture related damage is evident at the base of a number of brick masonry support piers; repair is recommended. Basement/foundation drainage issues should be evaluated by a Geotechnical Engineer, in conjunction with the above recommended stability review.
