## BUILDING USE AUDIT - CONDITION ASSESSMENT

### Town of Hadley, Massachusetts

#### North Hadley Village Hall

Middle Street

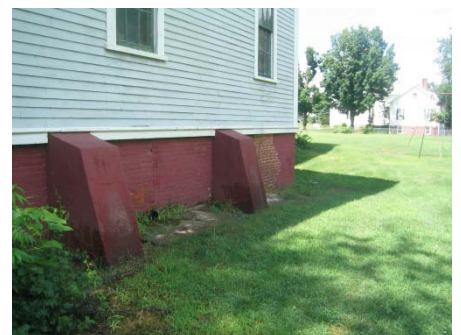
constructed. The original brick foundation walls were retrofitted with concrete “buttresses”, as shown in the photo on the preceding page. The front of the south wing was extended outwards to the west (1963 firehouse conversion) to accommodate fire trucks. A beam was provided in the ceiling above, clear spanning 32+/- feet in the north-south direction and supporting roof, Second Floor and exterior wall construction.

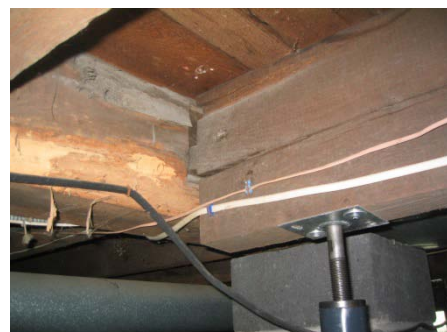
- As noted earlier in this report, mortise and tenon joints have failed in a number of locations and temporary, adjustable steel post shores have been installed (Photo). A thorough review of framing conditions should be conducted and permanent supports (with foundations) along with joist and beam hangers should be installed.

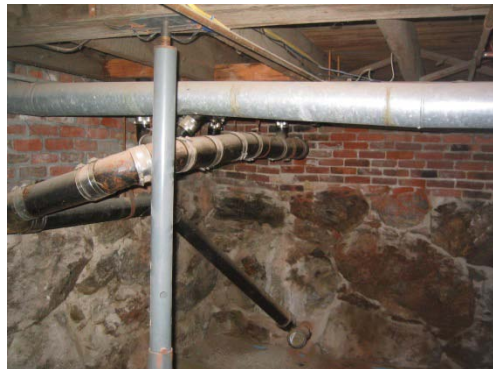
- Much of the mortar in the rubble stone foundation walls has been lost, due to years of water absorption (Photo). Joints in the brick sections of foundation walls above have also deteriorated, been damaged or bricks are missing. Repair mortar should be compatible with the original mortar and be of similar strength. Refer to the previously referenced reports for further information and detailed descriptions of the existing conditions.

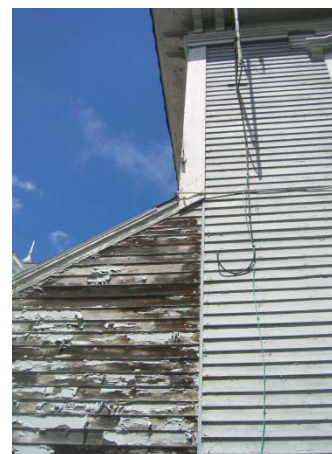
- There are numerous areas of painted wood siding and trim elements that have rotted and are significantly damaged (Photo). Refer to the previously referenced reports for further information and detailed descriptions of the existing conditions.

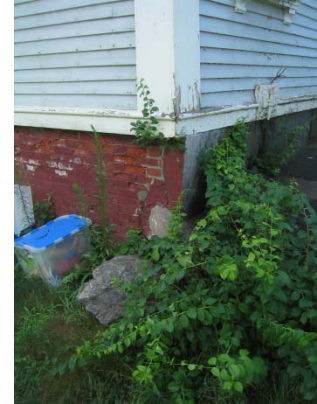
- Joints in the stone facing of the foundation wall are open in certain locations and/or stone sections have rotated (Photo). Repair and repointing is recommended. Refer to the previously referenced reports for further information and detailed descriptions of the existing conditions.
- The live load capacity of the First and Second Floor framing was not determined. Floor framing should be thoroughly investigated and evaluated in conjunction with potential future renovations to the building.
