BUILDING USE AUDIT - CONDITION ASSESSMENT
Town of Hadley, Massachusetts

Hadley Public Safety

15 East Street

MUNICIPAL FACILITIES STUDY and PLANNING Town of Hadley, Massachusetts

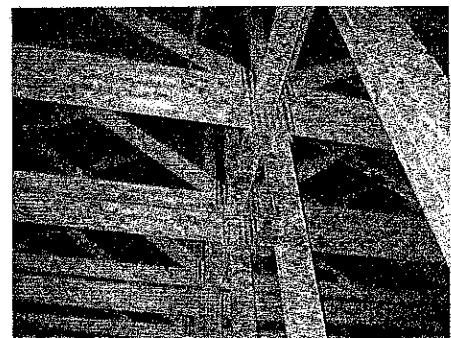
Structural Description: Based on FBRA site observations and discussions with Town personnel, the Police and Fire Station Complex is wood framed construction. Second Floor construction in the south wing and the connector could not be viewed; however, it is likely engineered lumber joists spaced at 16" o.c. supported by wood stud bearing walls and laminated veneer lumber (LVL) beams. Typical joist spans appear to be approximately 15 feet. The gable roof of the north (apparatus) wing is framed with metal plate connected prefabricated wood trusses spaced at 2'-0" o.c., which clear span the space below (approximately 50 feet). Due to the height of the trusses, they were fabricated in two pieces, including a top

"hat" truss which was field installed (Photo). Sloped roof construction in the south wing could not be viewed, but is assumed to be similar to that found in the apparatus wing. Roofing is asphalt shingles (some shingles are missing or damaged). The building was designed and constructed following the development of the seismic provisions in the Massachusetts State Building Code. Lateral forces (wind and seismic) are resisted by wood sheathed shear walls. Exterior, wood stud walls are clad with vinyl siding. Foundations are assumed to be conventional spread footings, with a concrete slab on grade at the First Floor (thickness unknown). Perimeter foundation/frost walls are cast-in-place concrete construction.

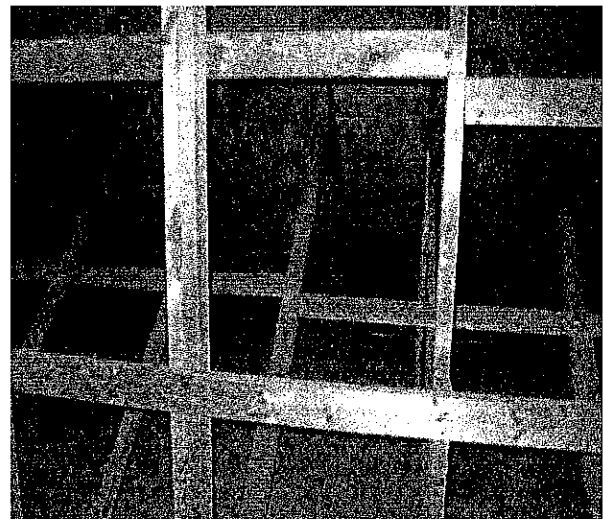
- Certain individual members of the prefabricated wood roof trusses which clear span over the Apparatus Room are braced with continuous 2x strongbacks (Photo). This member bracing is critical to the performance of the roof trusses under dead and live (snow) loads). To be effective, the 2x strongbacks need to be well anchored to the building (gable) end walls; it does not appear that this is always the case. FBRA recommends that these conditions be further reviewed and rectified, as appropriate. Similar conditions may exist at the roof of the south wing.

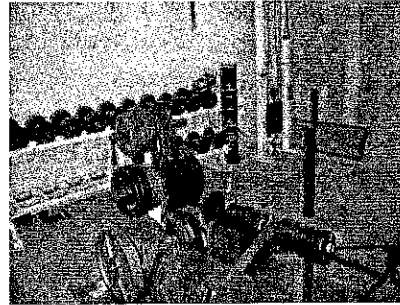
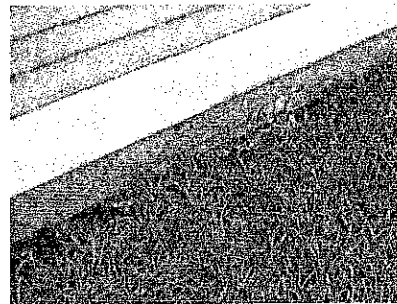
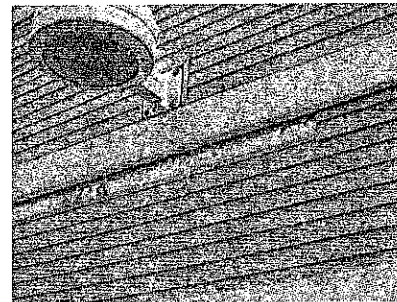
- As noted above, there is a Weight Room at the Second Floor level of section which connects the north and south wings (Photo). As the floor in this area was likely designed for a live load of approximately 50 psf, there is a potential for local overloading of the floor structure. Further review is recommended.

- Rigid insulation has been applied to the outside faces of the perimeter foundation/frost walls and protected with a cementitious board. This material is deteriorating in a number of locations, due to moisture, freeze-thaw, lawn maintenance, etc. This condition is not a structural concern with respect to the long term performance of the foundations.

- Wind suction has damaged and dislodged vinyl siding in certain areas on the back (west) side of the building. This is potentially hazardous condition, as airborne sections of siding could cause damage or injury. Further review and remediation of this condition is recommended.
