BUILDING USE AUDIT - CONDITION ASSESSMENT
Town of Hadley, Massachusetts

Russell School

Middle Street

MUNICIPAL FACILITIES STUDY and PLANNING Town of Hadley, Massachusetts

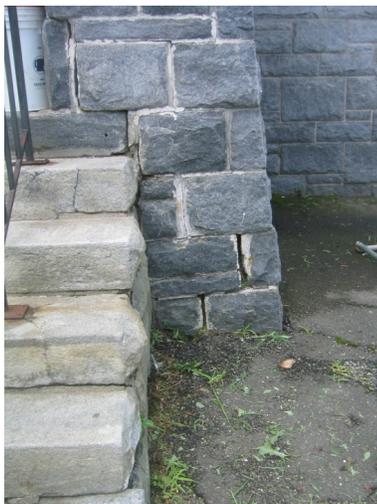
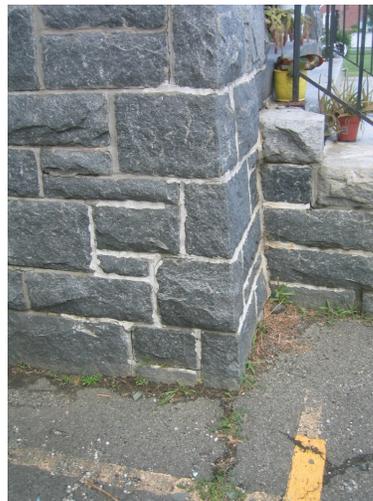
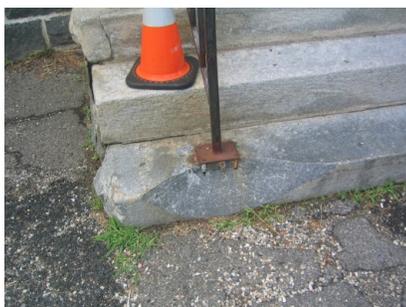
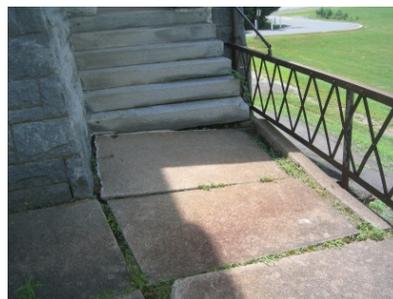
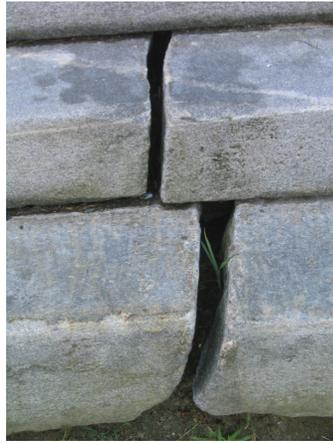
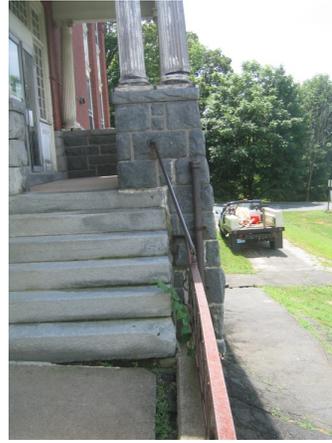
- As noted above, there is evidence of settling, subsidence and open stone joints in a number of locations, as shown in the photos of the entry porches below.

The condition of the stone is generally satisfactory; however, as seen in the photos above, there are numerous open and failed joints that require repair. Conditions observed appear to be related to settlement, inadequate maintenance, water and drainage issues (both roof and site), freeze-thaw action and the age of the building. In view of the conditions observed, the rate of deterioration will continue to increase with time. Repair of the stone joints at the base of the building and particularly at the entries (partial reconstruction required) should be conducted as soon as practical, to arrest future deterioration. Prior to conducting such repairs, however, settlement issues should be monitored and evaluated by a Geotechnical Engineer to determine if active conditions still exist. Roofing and drainage issues should also be addressed, to ensure that conditions will not reoccur once they are repaired.

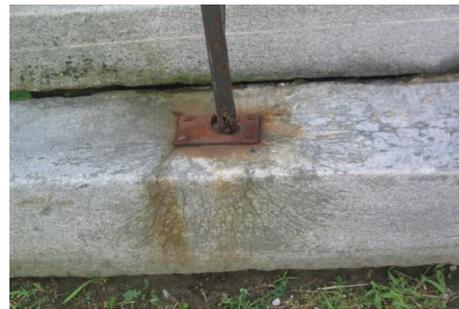
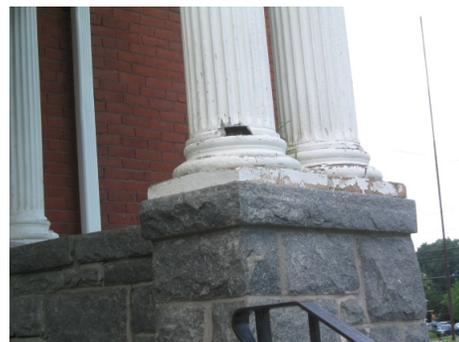
- Brick masonry chimneys are in poor condition; repair/reconstruction is recommended. Elsewhere, repointing of the brick masonry is required in limited areas.
- Railings at entry porches are improperly fastened to stone treads and are deteriorating (Photo). Replacement with properly anchored and protected bases is required.
- The condition of the wood trim (cornices, etc.) appears to be generally satisfactory. Inspection, cleaning, sanding and painting is needed in the long term.
- Wood columns at the east and west entry porches are open and appear to have suffered moisture related damage (Photo – North Porch). Further inspection and repair is recommended.
