# Historic Buildings Preservation Plan

Town of Hadley  
Massachusetts

Olde Mohawk Masonry  
& Historic Restoration,  
Inc.

APRIL 29, 2013

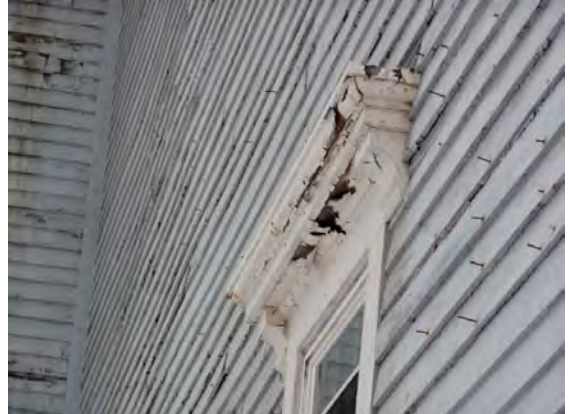
Figure 3- East Elevation showing just jacking at clapboard nails.

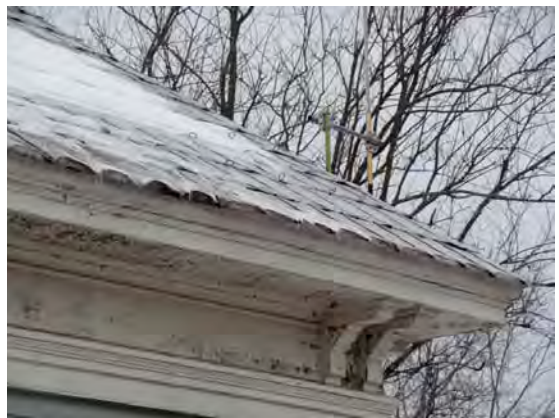
Roof tiles are rusting and their corners and edges are turned down. There are no drip edges present anywhere on the structure, causing water to work its way around, under and along the cornice. The turned-down roof edges are directing runoff back toward the building instead of away from it. [Figure 4] The most serious issues are the areas near the valleys and flashings where the roof of the 1871 addition meets the original structure. However, this construction detail is channeling water across the entire façade, which is the primary cause for the paint, wood and stone deterioration throughout the building. The roofing tiles are lapped and seamed to adjoining tiles and nailed at the top of the battens. Because of the manner in which the pressed metal roof tiles are installed, repair or replacement is not possible. Removal of a tile would destroy adjoining units because of the now-brittle seams and destructive means necessary to free the tiles from the fasteners.

Figure 4- West Elevation of Ell showing poor roof edge detail.

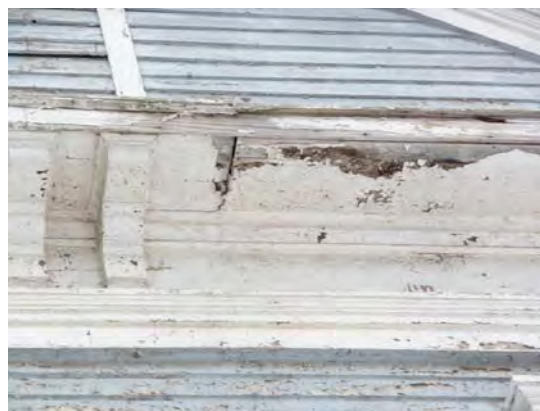
Figure 15- South Elevation at Ell showing deteriorated cornice and soffit at pediment.

*South facing gable of the Ell* Figures 15 shows a deteriorated soffit and rotted moldings along the lower part of the closed pediment.

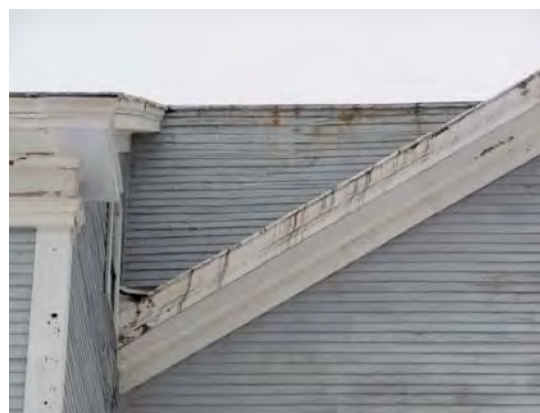
Figure 16- East Elevation at roof intersection showing poor construction detailing and deterioration from roof run-off.

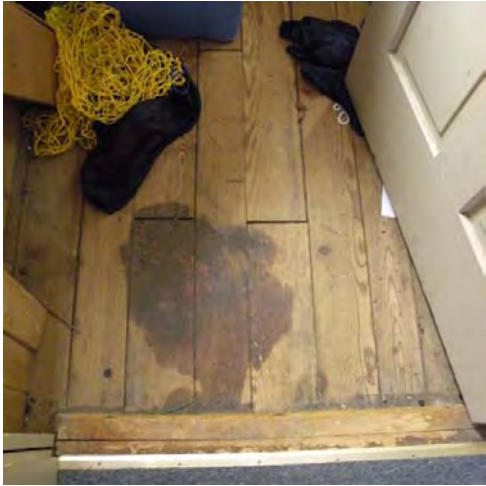
Original wide- board softwood flooring is found in support spaces. Unfinished softwood flooring can be seen in the closet below the Entry Hall stair [Figure 20] and may exist beneath the carpeted Entry Hall stair and 2nd floor landing. The Back Stair Hall and stair have painted softwood flooring. In general, the softwood flooring and painted finish are worn but sound. Narrow-strip hardwood flooring

Figure 20- Original flooring in closet.

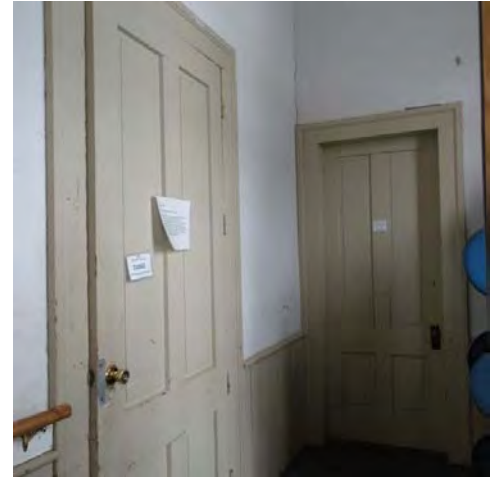
The predominant original wall treatment is composed of a painted, beaded wood board wainscot with chair rail and plaster above [Figure 23]. It exists or is evident in most of the main public rooms, support spaces and halls. In rooms such as the Assembly Hall the plaster has been covered with wood-grain laminate panels [Figure 24]. The wood wainscot is sound throughout. The plaster, where visible, appears to need minor work such as filling cracks. The finished surfaces, whether paint or varnish, require new coats.

There are five types of interior doors used throughout the building. Approximately 40% are 4-panel that appear to be original [Figure 23]. They range from requiring restoration work to refinishing work. The others are a variety of solid-core flush, hollow flush and 6-panel. The main door to the Assembly Hall is original and has exterior door construction details.

Figure 23- Typical original wainscot, plaster and doors.

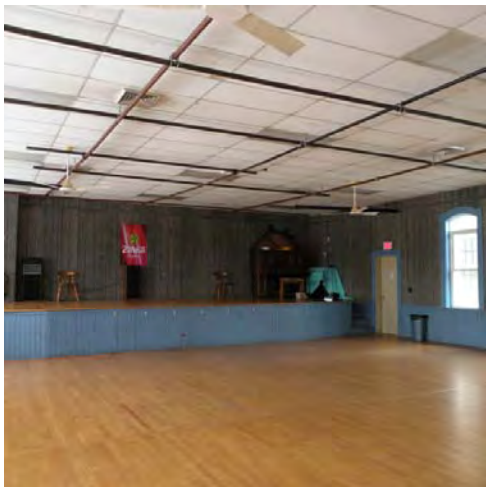
is found in the main public rooms. The Second Floor Assembly Hall and Stage are of maple with a clear-coat finish [Figure 21]. It is in excellent condition. Narrow-strip oak and maple flooring with clear-coat finish are used on the First Floor and are in very sound condition, requiring only refinishing work. It is possible that the hardwood flooring is not original and was applied over the softwood flooring. Further investigation is required to make this determination.

Figure 21- Maple flooring in Assembly Hall.

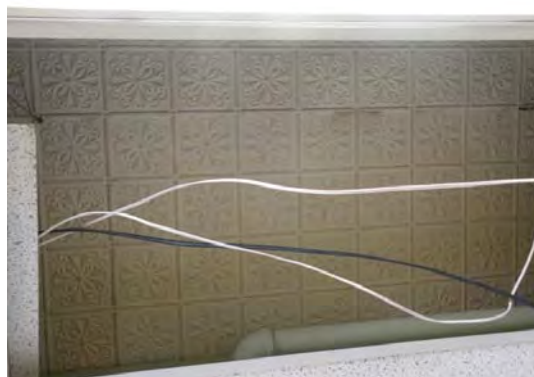
The First Floor Office (Library) has a painted pressed-tin ceiling above the false ceiling [Figure 31]. It appears to be in excellent condition.

**Figure 31- Pressed tin ceiling behind dropped ceiling in First Floor Office.**

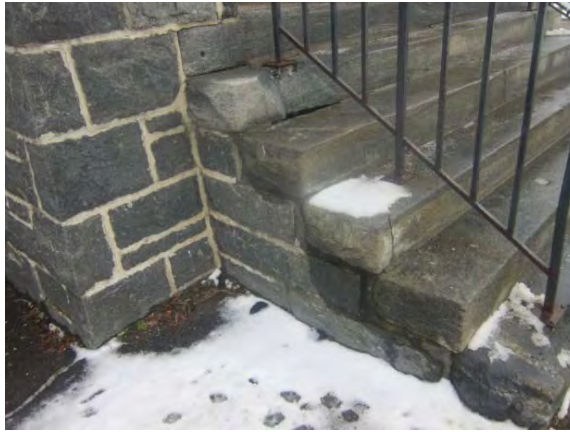
The condition of the quarry faced gneiss that compromises the foundation is very sound with a few localized, exceptions. At these locations, steps need to be replaced and some portions of walls rebuilt [figures 3, 4, 5]. Mortar joints have mostly worn evenly and need to be re-pointed [figure 6, 7]. At the corners of the building, continuous cracks that run through the stone units in places suggest the possibility of movement [figure 8].

Figure 4. Sections of the eastern porch have been repointed with an inappropriate material by an unskilled person or persons. Improper installation and later maintenance of the railing system has allowed the wrought iron to rust and expand. This has caused wholesale destruction of the stair treads.

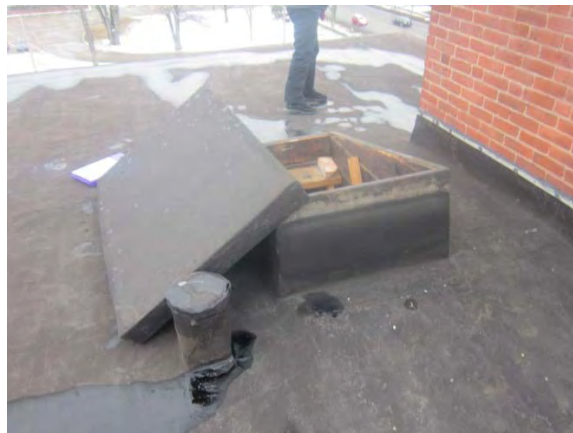
Figure 17. The roof hatch, curbing, protrusions, and condition of the modified bitumen roof all appear to be in good condition. These elements should be inspected quarterly for leakage and potential failures from the roof and the attic, underneath.

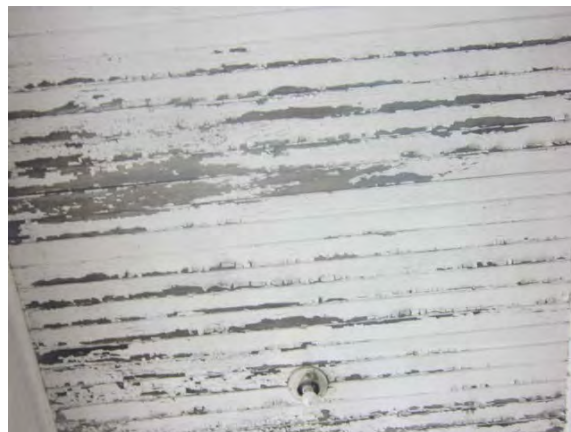
Figure 21. Underside of the west porch roof. The once-leaking roof was repaired or replaced but the ceiling was never prepped and repainted. The "alligatored" appearance of the failed coatings is indicative of lead in the paint.

reconstruction. Paint is peeling and fading at most locations. The undersides of the soffit and porch roofs show evidence of years of water damage that was stopped when roofing issues were addressed [figure 21]. Subsequent to this work, however, the soffits and ceilings were not scraped and painted. The steel fire escape has not been maintained and, as a result, the brick and stone masonry are rust-stained.

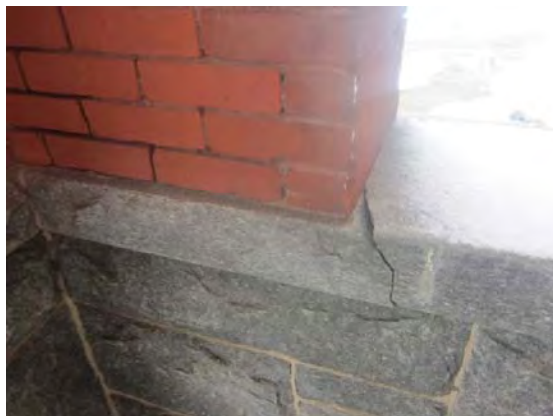
Figure 24. The porch side view of the crack discussed in Figure 23, above. Note the general deterioration of the brick mortar joints. Masonry will last for centuries if properly maintained. The repointing of mortar joints is critical to the longevity of a masonry structure.

Empty or failing mortar joints should be repointed as needed. The mortar should be tested for composition and appropriate recipe specified for repointing according to ASTM C-1324-03 *Standard Test Method for Examination & Analysis of Hardened Masonry Mortar* by a qualified materials conservator. The material must also be sympathetic in texture, color, strength and appearance to that in adjoining areas. All stone surface areas of Russell School must be repointed.

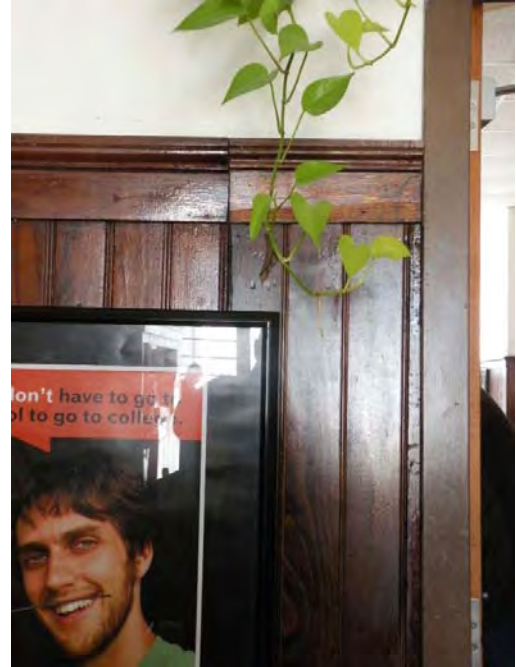
Russell School retains the vast majority of its original interior finishes. There are limited areas such as the Second Floor Main Hall where original finishes have been removed or altered to accommodate newer construction [figure 26]. In general, the original finishes are sound and appear to need only routine repairs such as painting.

Figure 26- 1st Floor Corridor showing newer paneling and crown molding to the right abutting original paneling and molding to the left.

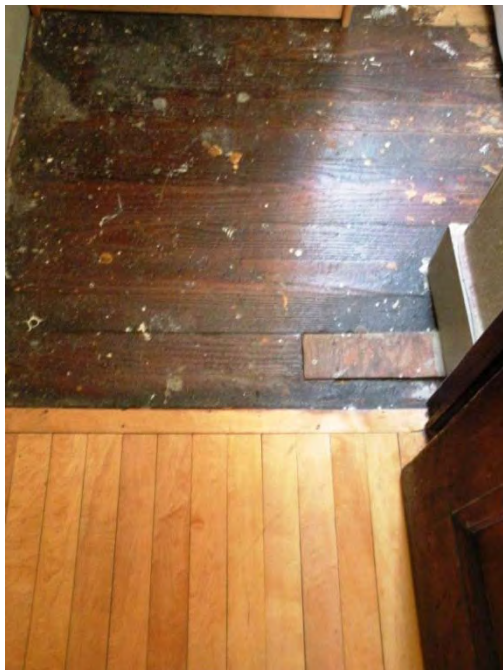
Figure 27- 2nd Floor Closet with (probable) original Southern pine flooring and overlaid with maple flooring in the corridor.

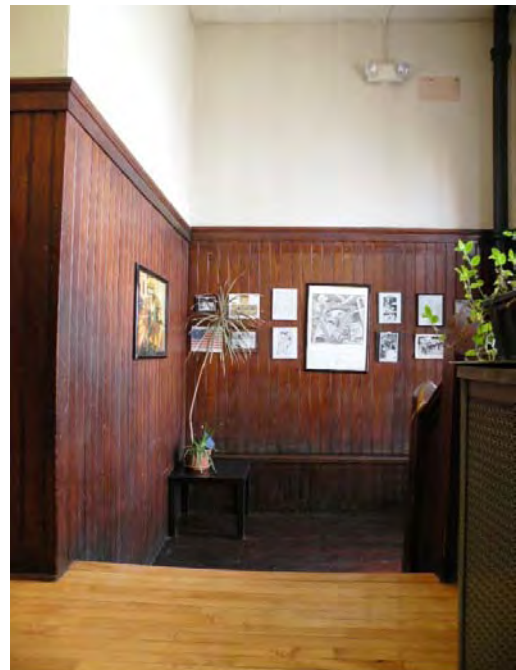
Figure 28- Second Floor Corridor with typical common space wainscot, crown molding and plaster wall. Note maple flooring in foreground and pine flooring at stair landing.

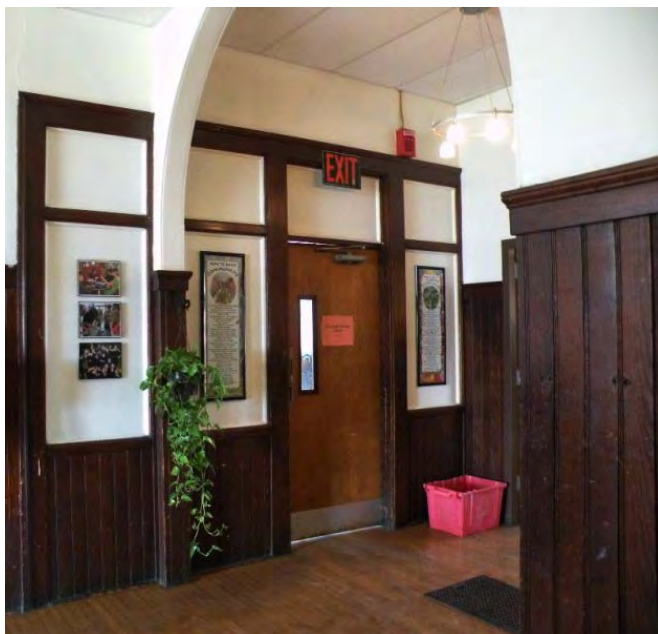
The painted plaster walls including the large arched openings in the Main Hallways (that mirror the design of the exterior windows) are articulated at all outside corners with staff beads [figure 31]. The plaster is in very sound. Paint is in poor condition.

Figure 31- 1st Floor Corridor- plaster arch with double-beaded edge detail.

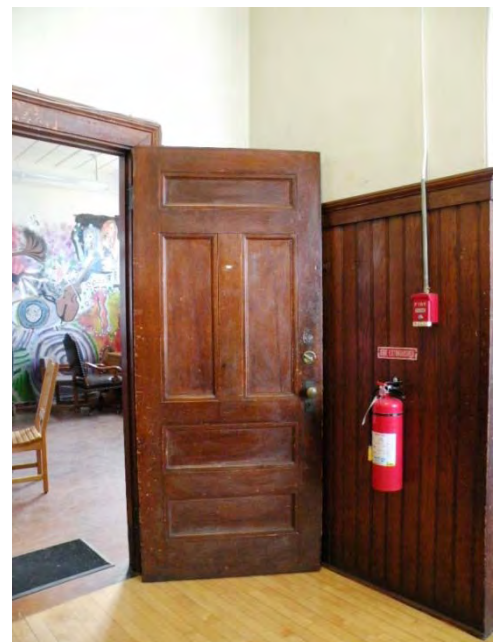
Except for exterior doors and doors in new construction, all door openings and doors appear to be original. Typical doors have five flat panels [figure 32]. Classroom and office doors accessed from the main halls have an additional borrowed light glass transom. The doors are finished to match the wainscot. Door knobs, probably original, are cast bronze with cast bronze escutcheons [figure 33]. Doors are in sound condition except where hardware has been added or removed.

Figure 32- Typical original door.

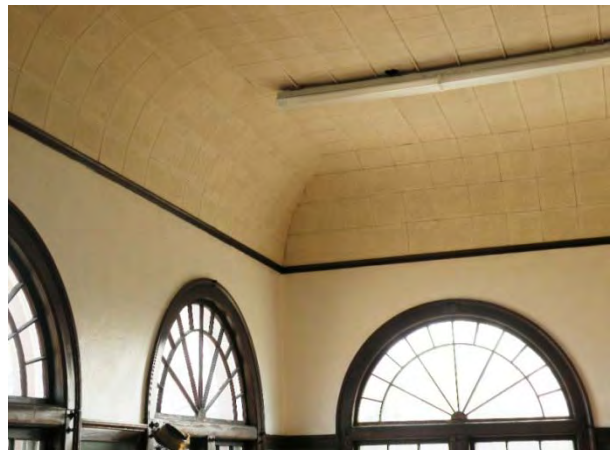
Figure 36- 2nd Floor Classroom with coved ceiling and applied acoustical ceiling tile.

Typical ceilings in halls and offices are flat. Typical ceilings in classrooms are coved where they meet the walls. Both ceiling types, throughout the building, are covered with painted acoustic ceiling tiles. (The sound-absorbing property of acoustic tiles is compromised once they've been painted.) The ceiling tiles appear to have been applied directly to the original plaster ceiling [figure 36].

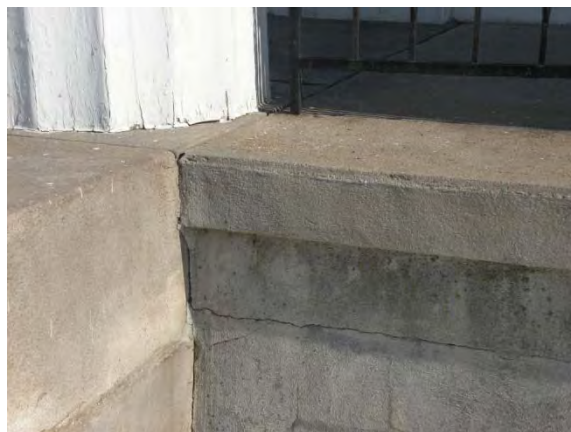
*Figure 4- West Portico plinth parge coat.*

- **Recommendation #3** (*Figure 4*)- prepare the existing surface to receive a two-coat, cement-based pargeing system with epoxy resin binder.

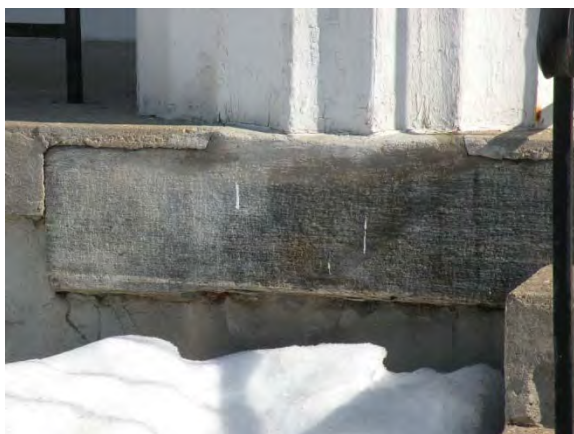
*Figure 2- West Portico showing separation of stone and concrete.*

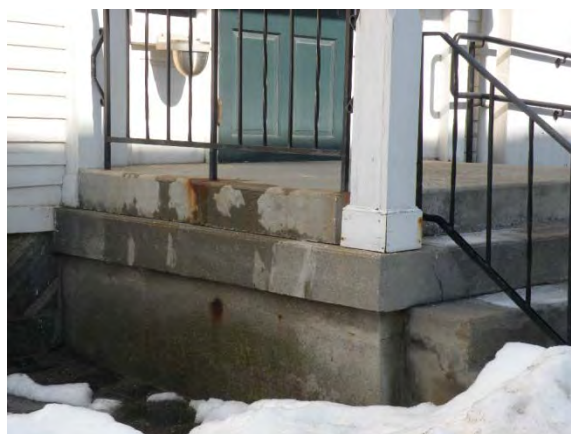
*Figure 5- Crack at South Porch column.*

- **Recommendation #4** (*Figure 5*) - close and seal crack with an epoxy mortar and inject epoxy resin to bind the concrete sections together.

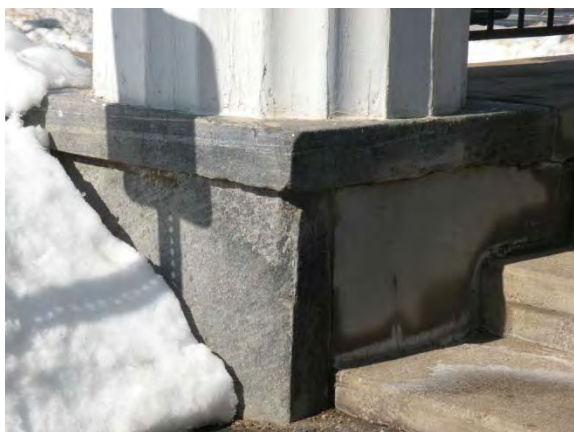
*Figure 3- West Portico deteriorated parge coat.*

- **Recommendation #2** (*Figure 3*) - remove and replace render coat with a two-coat, cement-based pargeing system with epoxy resin binder.

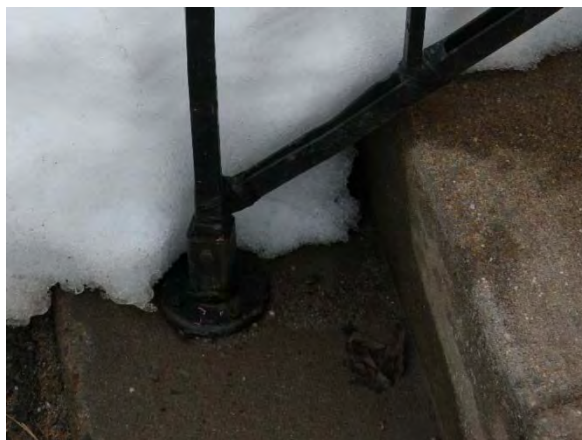
*Figure 6- South Porch newel at handrail.*

**Recommendation #8\_**(Figure 6) - weld a new steel sleeve in place to join the pieces together, file smooth, prime and paint.
