BUILDING USE AUDIT - CONDITION ASSESSMENT

Town of Hadley, Massachusetts

Town Hall

100 Middle Street

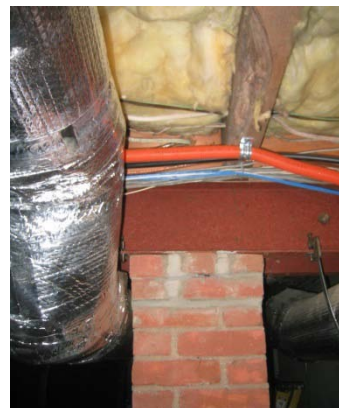
First Floor construction consists of 3"x9" wood joists spaced at 22"+/- o.c., spanning 13+/- feet in the east-west direction to double, 9" deep steel channel beams. Beams are supported on brick masonry piers, 12" or 16" square (Photo). The steel channels are not original. A section of the First Floor was reinforced to support the elevator (presumably during the 1968 renovations).
