## BUILDING USE AUDIT - CONDITION ASSESSMENT

### Town of Hadley, Massachusetts

#### North Hadley Village Hall

Middle Street

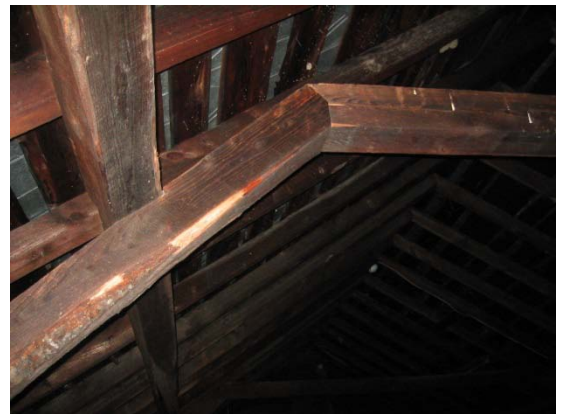
The roof of the north wing is a simple gable form with an east-west ridge line and a centrally located bell tower at the west end. The roof of the south wing is also a gable form, with a north-south ridge line. In each case, wood rafters and purlins span to timber trusses which clear span the width of the wing (nearly 40 feet and 30 feet in the north and south wings, respectively). Rafters and purlins in the south wing are undersized (2½" x 5½" and 6"x6", respectively) and are considered to be structurally marginal (Photo). The size of roof framing members in the north wing was not determined. Roofing is metal tiles, attached to intermittent wood battens, nailed to the rafters.
