BUILDING USE AUDIT - CONDITION ASSESSMENT
Town of Hadley, Massachusetts

Hadley Public Safety

15 East Street

MUNICIPAL FACILITIES STUDY and PLANNING Town of Hadley, Massachusetts

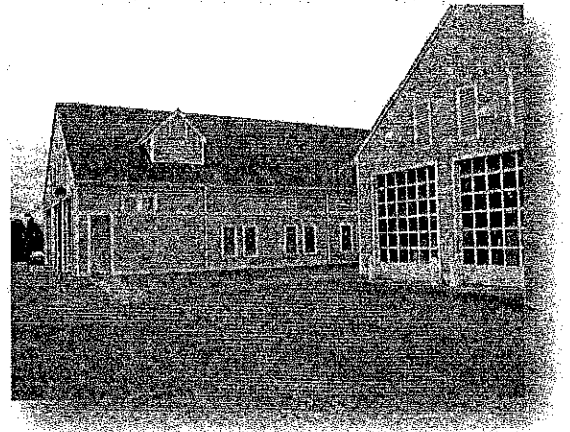
The building is composed of a two-story south wing and a one-story, three-bay apparatus wing to the north. Program elements at the First Floor of the south wing include Offices, Dispatch, Holding Cells and various support spaces for the Police and Fire Departments. Additional departmental offices are located at the Second Floor. A Weight Room is located in the unassigned Second Floor space connecting the north and south wings. There is an unused Attic space over the apparatus bays of the north wing. A passenger elevator, located near the front/east egress stair connects the First and Second Floors of the south wing.

"hat" truss which was field installed (Photo). Sloped roof construction in the south wing could not be viewed, but is assumed to be similar to that found in the apparatus wing. Roofing is asphalt shingles (some shingles are missing or damaged). The building was designed and constructed following the development of the seismic provisions in the Massachusetts State Building Code. Lateral forces (wind and seismic) are resisted by wood sheathed shear walls. Exterior, wood stud walls are clad with vinyl siding. Foundations are assumed to be conventional spread footings, with a concrete slab on grade at the First Floor (thickness unknown). Perimeter foundation/frost walls are cast-in-place concrete construction.

- Certain individual members of the prefabricated wood roof trusses which clear span over the Apparatus Room are braced with continuous 2x strongbacks (Photo). This member bracing is critical to the performance of the roof trusses under dead and live (snow) loads). To be effective, the 2x strongbacks need to be well anchored to the building (gable) end walls; it does not appear that this is always the case. FBRA recommends that these conditions be further reviewed and rectified, as appropriate. Similar conditions may exist at the roof of the south wing.
