BUILDING USE AUDIT - CONDITION ASSESSMENT
Town of Hadley, Massachusetts

Russell School

Middle Street

MUNICIPAL FACILITIES STUDY and PLANNING Town of Hadley, Massachusetts

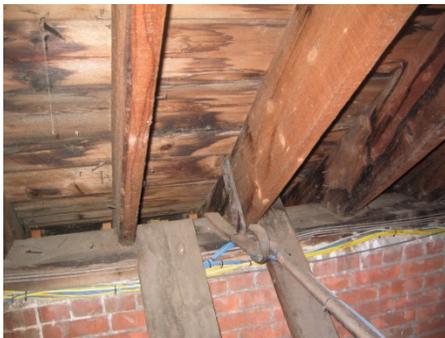
The main roof is a shallow hipped form with a central, flat area at the top. Wood rafters are full 2x10's, spaced at 16" o.c. Steel ties (one on each side of the bell tower) run through the Attic space in the north-south direction, tying the exterior walls together (Left Photo). The masonry walls of the bell tower are supported above the Attic floor, on wrought iron beams and cast iron columns (Right Photo). Roofing on the sloped sections of the roof is the original slate shingles.
